State of Utah DEPARTMENT OF NATURAL RESOURCES Division of Oil, Gas & Mining

Inspection Report Minerals Regulatory Program August 30, 2012

Mine Name: Champlin #1	Permit Number: S/023/0104	
Operator Name: Nephi Sandstone	Inspection Date: August 28, 2012	
Inspector(s): Wayne Western	Time: 4:05 -4:30 PM	
Other Participants: none	Mine Status: ACT	
Weather Condition: 93 degrees mostly clear skies	Last Inspection: April 1, 2009	
Bond Renewal Date: 02/10/2014	Bond Amount: \$19,700.00	
Surface Ownership: BLM	Mineral Ownership: BLM	
Last Year of Production: Acreage: 4 Acres

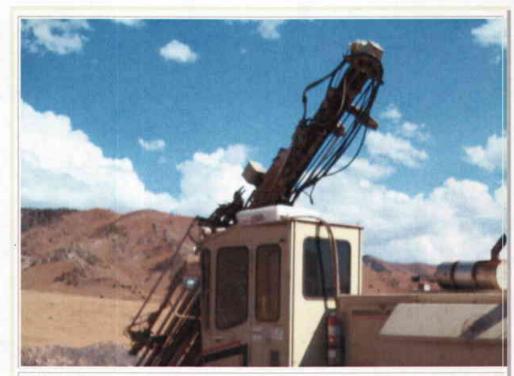
There is a drill rig on the site but no other pieces of equipment. Because the BLM has stopped production until a determination if finalized about the material being leasable or locatable no production can occur. There was no sign of mining activity.

Drill rig on site

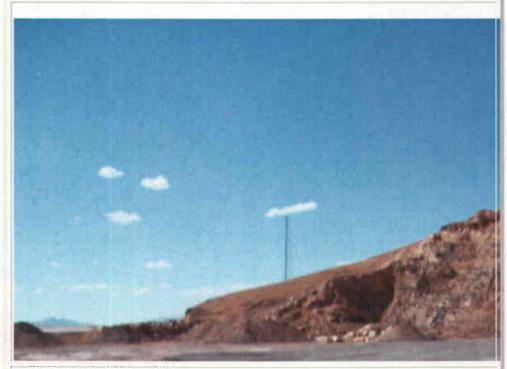
Pad area, tower is a landmark for the site.
